## Two burnt-down houses examined

**J. P. Flamman** Vestigia, Netherlands

● **After two experimental constructions of LBK houses burnt down accidentally, Dutch archaeologists observed and recorded the formative processes. The article brings together information on the two years of the project.**

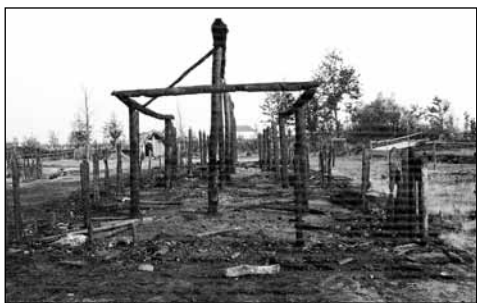
**Fig. 7** Burnt-down Stein 29, seen from the northside June first 1995. The fire started on the right-corner. ■

Within one and a half hours, most of the damage was done. The fire smouldered and burned for another 30 minutes until the firemen put it out. JK 13 was extinguished with great force, but at the request of the experimental archaeologist, Stein 29 was put out with a gentle stream of water. **Figures 7 and 8** give an impression of the remains one day after the fire.

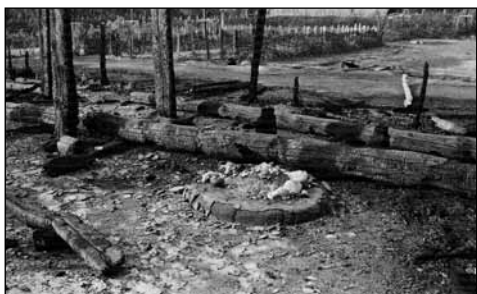
**Fig. 8** Interior of Stein 29, one day after the fire. Benches are still in position. ■

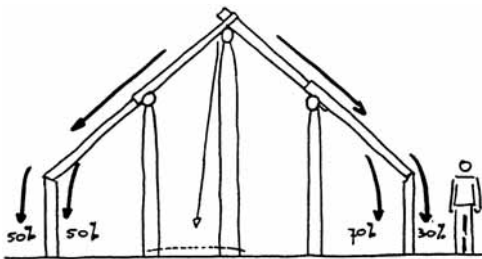
These observations were made at both houses. As a result of the intense fire, the wickers of the thatched roof burnt very quickly. Burning straw, including the laths, slid down along the rafters. Influenced by the wind, the burning straw fell in different proportions inside and outside the walls. On the east side of the house the ratio

inside:outside was about 50:50. On the west side, where the wind clearly had an influence, it was roughly 70:30 (**fig. 9**). The top ridge of both houses was finished with loam. This clayey material became fired by the blaze and fell to the east side of the buildings' interior under the influence of the prevailing wind.

Fig. 9 The ratio of slid straw inside and outside the house. Under influence of the west wind it was on the east side 50%:50% and on the west side 70%:30%. ■

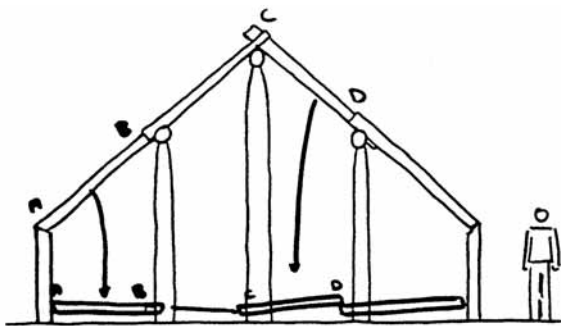
The differences in the collapse of the houses, especially the roof-timber, resulted from differences in the use and construction of the rafters. In Stein 29, where each rafter from the top ridge to the wall was made of two pieces, the burning of the joints caused these rafters to fall straight down into the house, with almost the same orientation as they had been fixed on the roof (**fig. 10**).

Fig. 10 Collapsing rafters in Stein 29. The position on the ground is the same as at the roof. ■

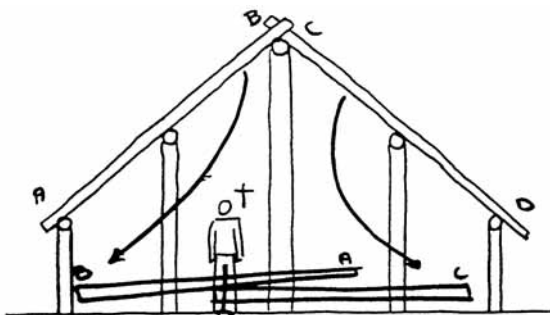
In contrast, the rafters of JK 13 were of one piece. As a result of the heaviness of their upper part, they tipped over and lost their balance on the side-plate (fig. 11). The end connected to the other rafter on top of the ridge-plate now lay close to the wall. This was noticed on several occasions. Other rafters remained in place or slid just along the side plate and the wall outside the house.

Fig. 11 Collapsing rafters in JK 13. The position on the ground is opposite of the one at the roof. ■

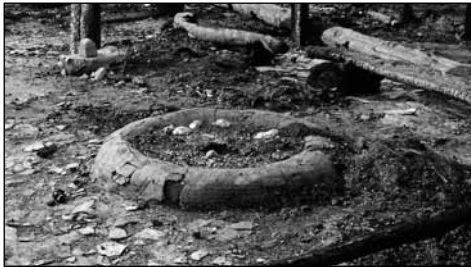
**Fig. 14** The northern fireplace with the benches still in position, two days after the fire. ■

Nothing was left from the interior except for some black benches, some still located around the fireplace. In the fireplace there stood some small ceramic vessels, undamaged, but extra fired (fig. 14). The cooking stones beside them had burst into a dozen pieces. The contents of one of the storage vessels—green

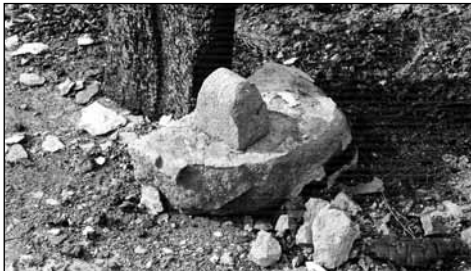
**Fig. 15** The burstured quern in Stein 29, two days after the fire. ■

peas and beans—were completely charred. The handle of a stone axe was gone and the axe itself was cracked, but it still maintained its shape. A quern made of German-Eifel basalt lava was burst by the heat (**fig. 15**).

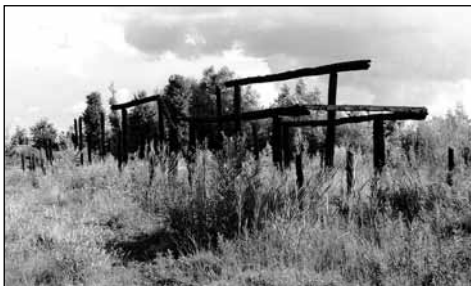
**Fig. 16** The overgrown location of the burnt house Stein 29, two years after the fire. ■

For two years after the fire the site of Stein 29 has been monitored regularly and some changes have been documented. In the first half year, nothing grew on the spot, except for the small places where the burnt floor was disturbed (e.g. where the thickness of the fired loam floor had been tested). At first, everybody left all the objects untouched “for the experimental research”. However, during the second year people began to collect wood and charcoal for other fires in the immediate neighbourhood. In this way, objects began to disappear. Overtime, the location of Stein 29 became more overgrown (**fig. 16**).

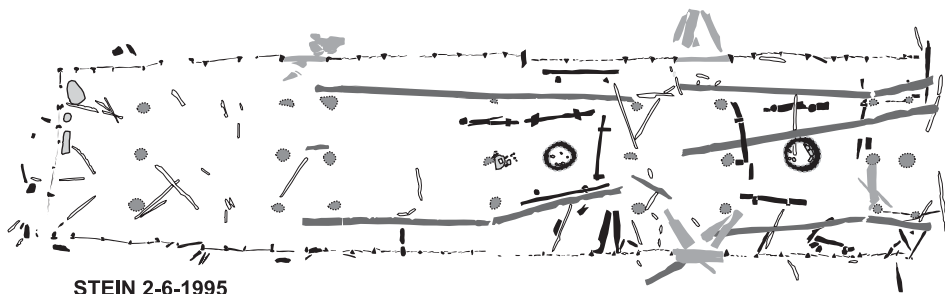
STEIN 2-6-1995

Fig. 13 The plan of the burnt house Stein 29, two days after the fire. ■

and the starting point of the fire and the direction of the wind. The fire started in the northwest corner of the house. Here, the burnt layer is rather thin, 1-2 mm. In the southeast corner, the fired loam layer becomes thicker and thicker, up to a few millimetres. This probably resulted from the intense heat of the blaze as it blew in a southeast direction, effecting this corner more than other areas.

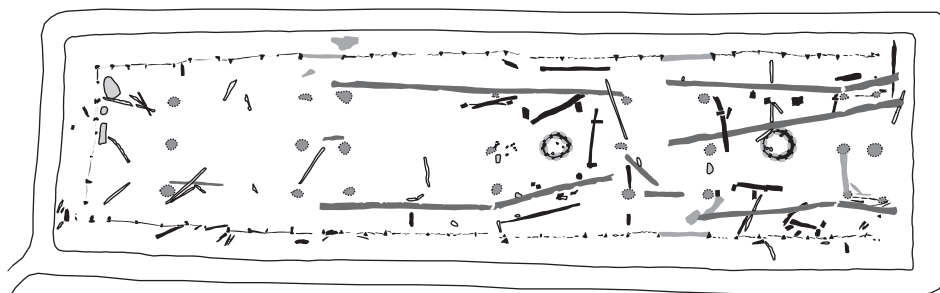
STEIN 12-7-1997

Fig. 17 The plan of the burnt house Stein 29, two years after the fire. ■

In July 1997, Stein 29 was again completely recorded (**fig. 17**). [JK 13 had been rebuilt during the months after the fire.] The drawings from 1995 were compared with the situation in the summer of 1997. Around the former house, a ditch of 70 cm deep was laid out as a safety-trench. Pieces of wood located along this ditch were moved away. Several wall posts and planks had broken off and these were thrown in the house.

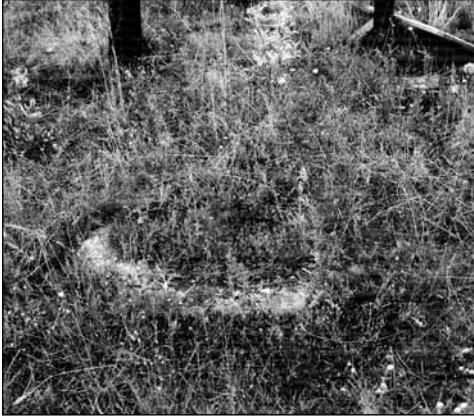
**Fig. 18** In 1997 the northern fireplace has eroded to a heap of loam and charcoal. ■

had been trampled to a very small grit and powder. The fireplaces had eroded to heaps of loam and charcoal and the cooking stones were not recognizable anymore (fig. 18). All the intact objects had been taken away. The broken quern, however, was still there, since as a result of the fire it had become useless. Now its pieces were spread over an area of some meters. The particular parts of the quern were no longer identifiable (fig. 19).

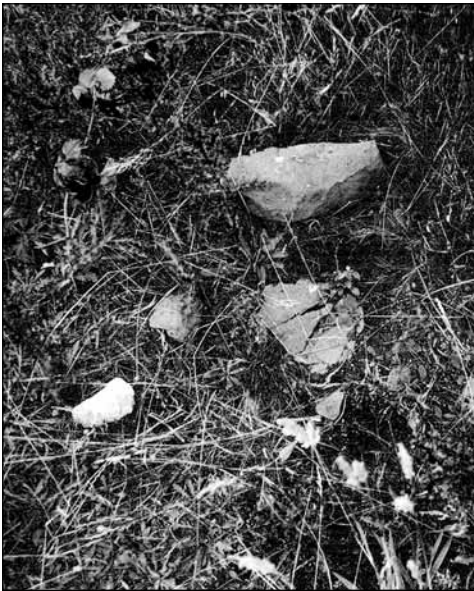
**Fig. 19** In 1997 the quern is spread in many pieces over some square meters. ■
