## Two burnt-down houses examined

**J. P. Flamman** Vestigia, Netherlands

● **After two experimental constructions of LBK houses burnt down accidentally, Dutch archaeologists observed and recorded the formative processes. The article brings together information on the two years of the project.**

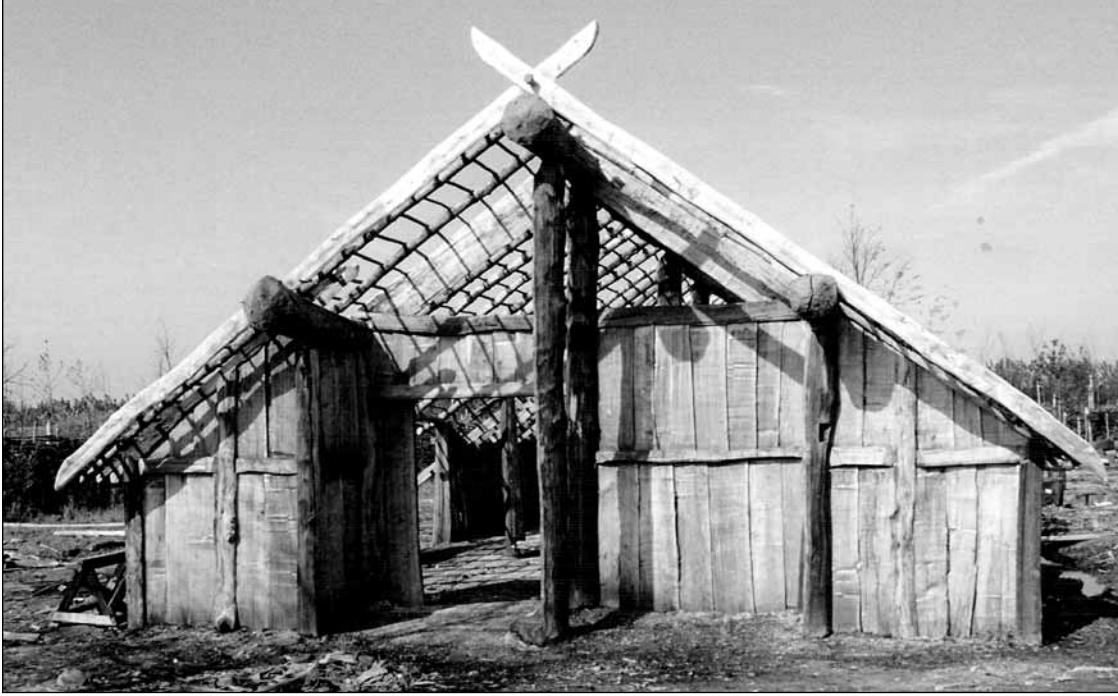
**Fig. 2** The construction of the southeastern wall of Stein 29. Vertical placed planks between the outer posts. ■

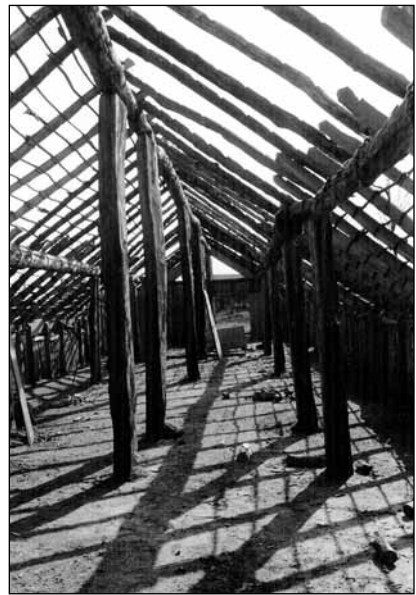
The roof bearing construction consisted of several elements (**fig. 3**). The rafters, the stems hanging down from the top ridge, were in two parts.

The upper-rafters hung in joint pairs over the ridge down to the side-plate. Each wall post supported a rafter from the side-plate down to the wall. The laths for attaching the straw cover were tied with wickers on the rafters. Between two laths the thatched roof of more than 20 cm thickness was bound again with wickers and with the cornstalks hanging down.

**Fig. 3** The roofconstruction of Stein 29 with the short rafters from the ridge to the side plate and from the side plate to the wall posts. ■

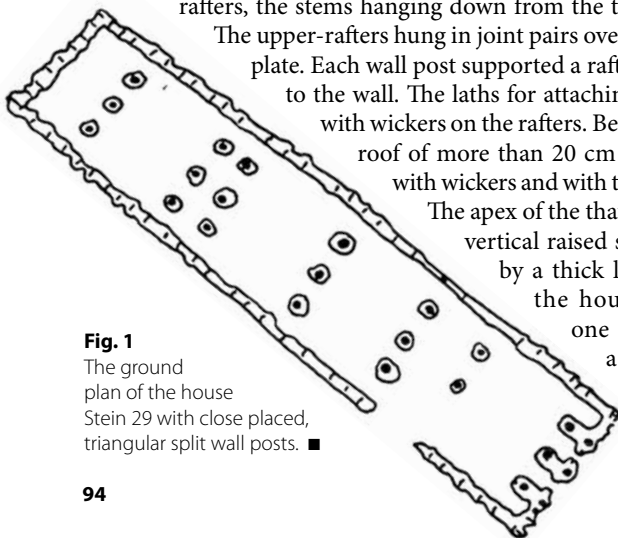
The first house that burnt down was built following the ground plan of structure #29 at the archaeological site of Stein (Modderman 1970, 90). This house was about 32 meters in length and its width varied between 6.0 and 7.5 meters (**fig. 1**). Its walls were made completely of wood. The archaeological postholes clearly showed that the wall posts were made of triangular split trees. These posts were made of oak. Between them, thinly split planks (2-6 cm) were placed to build the wall. In the northwest part of the house these planks were placed horizontally. In other areas, the planks stood vertically (**fig. 2**). At the reconstructed house the chinks between planks were filled with a mixture of wool and loam. The wall had a height of 1.5 meters.

**Fig. 1**  
The ground plan of the house Stein 29 with close placed, triangular split wall posts. ■

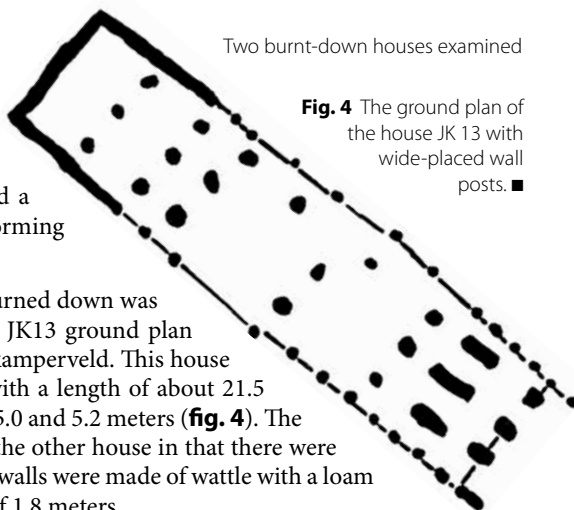
The second house that burned down was a construction based on the JK13 ground plan from the site of Geleen-Janskamperveld. This house was smaller than Stein 29, with a length of about 21.5 meters and a width between 5.0 and 5.2 meters (**fig. 4**). The wall structure differed from the other house in that there were not as many outer posts. The walls were made of wattle with a loam cover and stood to a height of 1.8 meters.

**Fig. 4** The ground plan of the house JK 13 with wide-placed wall posts. ■

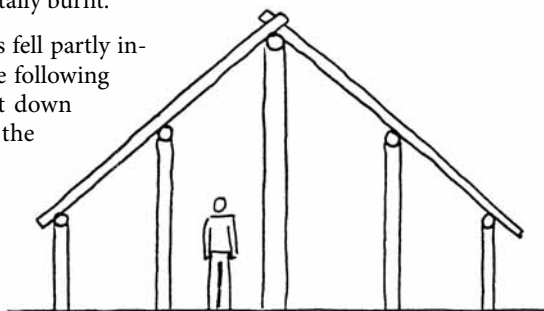
The roof of JK 13 was slightly different from Stein 29. Its rafters hung down in pairs from the top ridge down to the wall plate (**fig. 5**). The thatched cover of JK 13 was tied up on the same way as Stein 29. In other respects, JK 13's roof, doors, seats, and shelves were the same as Stein 29.

**Fig. 5** Cross-section through the house JK 13. ■

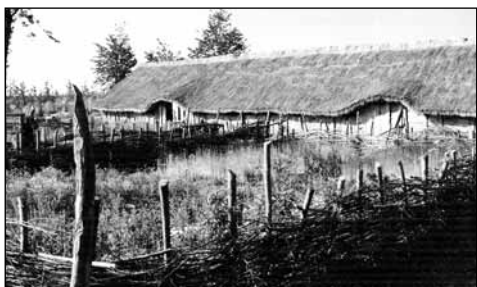
**Fig. 6** The eastside of house Stein 29, one year before the fire. ■

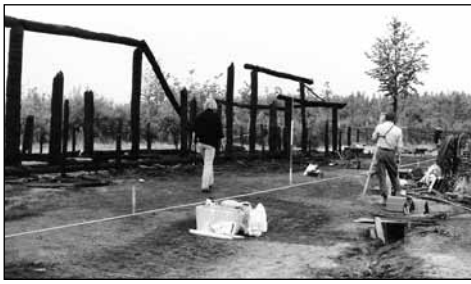
**Fig. 12** A team of archaeologists of the University of Amsterdam joins the experimental archaeologists of Archeon in measuring, drawing and taking pictures of the remains of Stein 29. ■

Two days after the fire, the ruins of Stein 29 were recorded like an excavation with precise measurements, scaled drawings, and photographs. A team from the University of Amsterdam interrupted one of their nearby excavations for two days to help the experimental archaeologists at Archeon (fig. 12, 13). During this documentation, special attention was paid to the loam floor and the “prehistoric” objects in the southern part of the house which had not been rescued.
